Route 66 Transportation Study
Portland and East Hampton, CT

Existing Conditions Technical Memorandum (DRAFT)

**RiverCOG and the Towns of
Portland & East Hampton**

August 2018

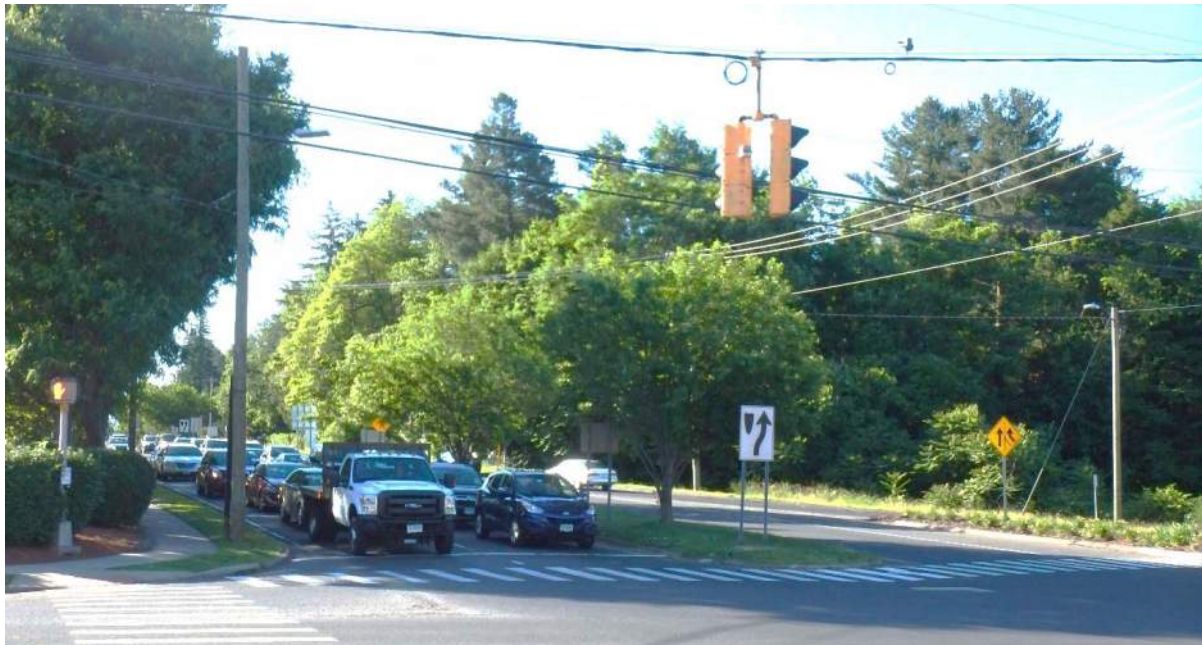
The section of Route 66 in the study area is approximately 11 miles long. Approximately 5.4 miles of which is located in Portland, and 5.6 miles of which is located in East Hampton. From the Portland town center to the Route 17 junction (approximately 2 miles) the roadway consists of four travel lanes, two in each direction, with a raised median and dedicated left turn lane at major intersections. For the remainder of the corridor, the cross section becomes two lanes, one lane in each direction, and widens to provide exclusive left or right turn lanes at key intersections. Within the study area, Route 66 contains thirteen signalized intersections, which are further described in Section 2.2.

Intersection of Main Street (Route 17A) and Marlborough St (Route 66) in Portland

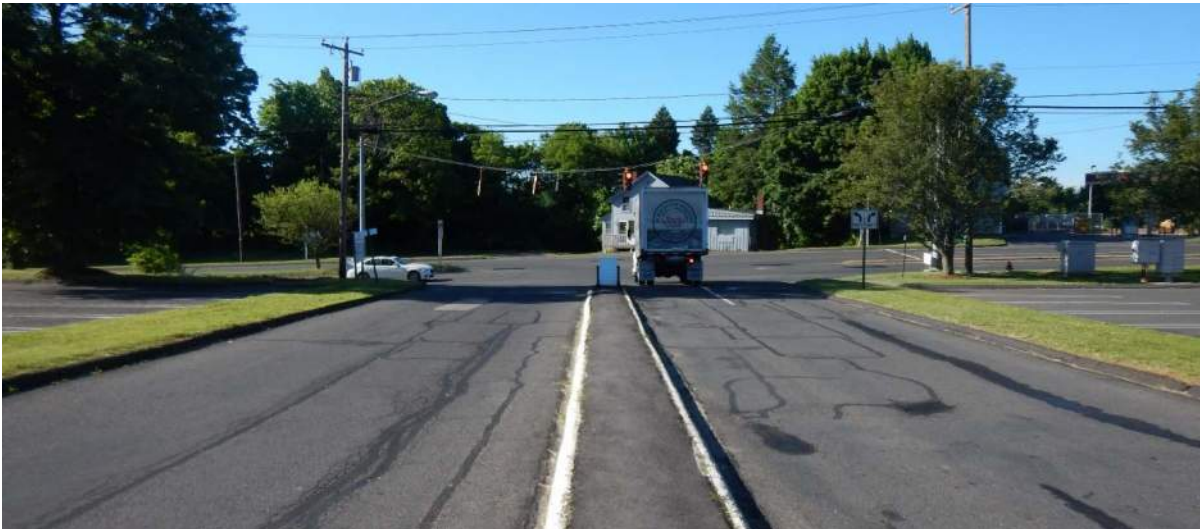
The Portland Shopping Center Driveway intersects Route 66 at a signalized T-intersection. The driveway provides an exclusive left turn and right turn lane exiting the plaza and a single entering lane. The entrance and exit are separated by a narrow raised island. A secondary unsignalized right-only exit is provided approximately 180 feet west of the signalized driveway. There is no traffic control device at this exit. The driveway serves an approximately 54,000 square foot shopping plaza comprised of a grocery store, gym, and various retail locations.

Portland Shopping Center Driveway, looking South towards Route 66

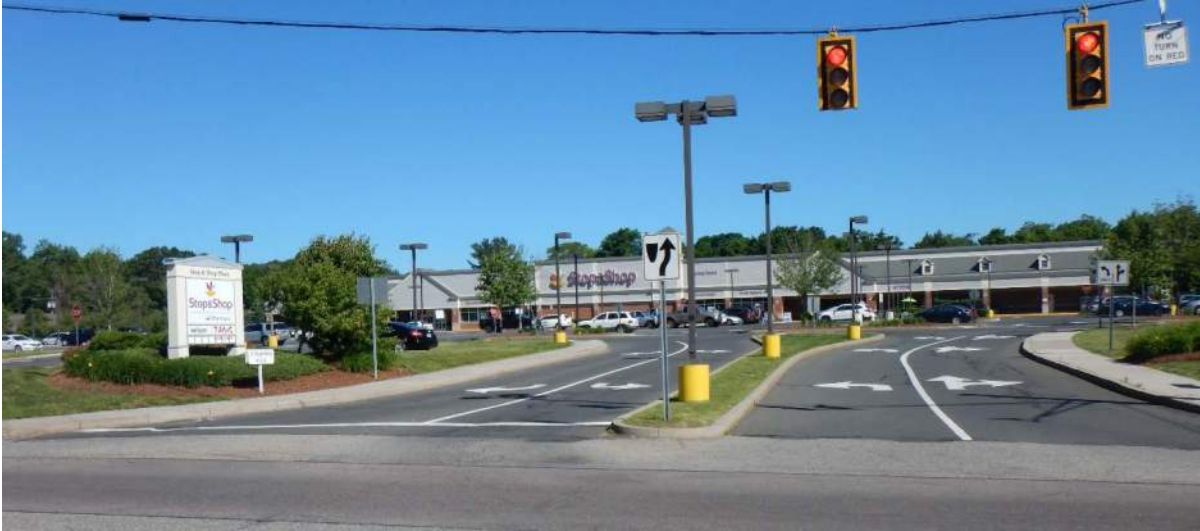
The East Hampton Shopping Center Driveway and Eversource Driveway intersect Route 66 at a signalized intersection. The East Hampton Shopping Center Driveway provides two lanes entering the plaza and two lanes exiting the plaza, separated by a raised island. The East Hampton Shopping Center consists of an approximately 75,000 square foot shopping plaza anchored by Stop and Shop, as well as a standalone 3,500 square foot Bank of America. The Eversource Driveway provides a single entrance lane and a single exit lane providing access to the Eversource Area Work Center.

Looking North towards the East Hampton Shopping Center Driveway

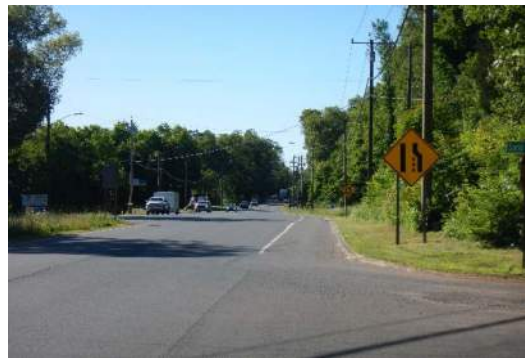
- The current lane merge warning sign at the eastbound four-lane to two-lane transition area east of Gospel Street in Portland is not installed at an appropriate location that meets the design guidelines included in the MUTCD. Additionally, the lane-reduction transition pavement marking isn't provided to guide traffic through the transition area.
- School zone signs and speed limit signs for school zone do not exist in vicinity of Childs Road, where East Hampton Middle School is located along the corridor
- Speed enforcement signs including change of speed limit signs and radar speed signs don't exist and are considered necessary to help regulate travel speeds on the corridor.

Merge sign on Route 66 in East Hampton, looking East

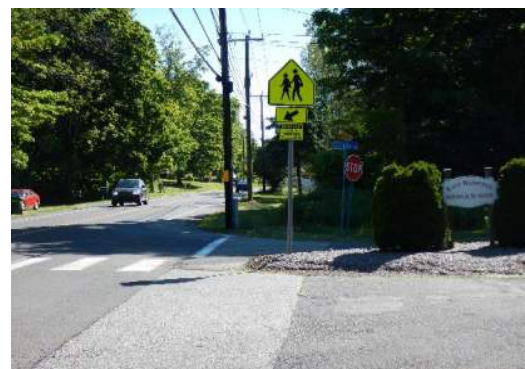
School Crossing sign on Route 66 near East Hampton Middle School

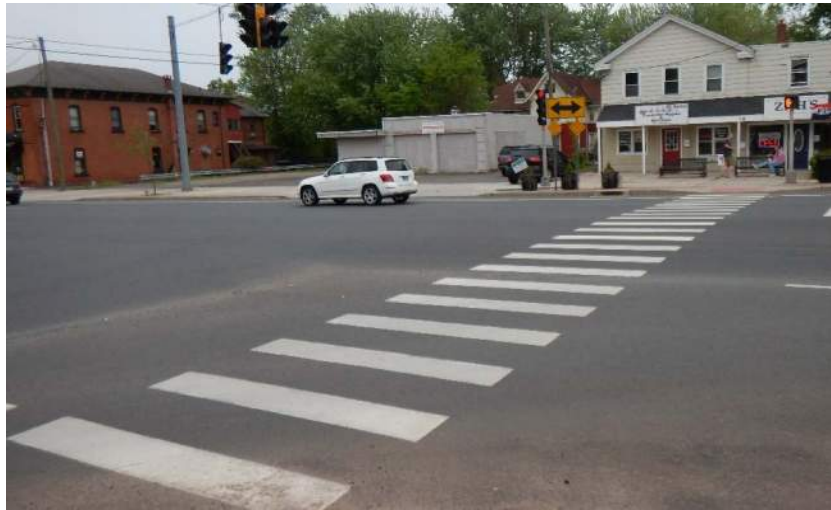
- Marked crosswalks, sidewalk ramps with warning strips, and pedestrian signals are provided on the north leg and east leg of the intersection of Main Street and Marlborough Street. Concrete sidewalk is present within the channelized right-turn island to provide continuous sidewalk on the east leg of the intersection. The traffic signal at the intersection provides an exclusive pedestrian phase upon the actuation of pedestrian push buttons.

**Crosswalk at the intersection of Route 66 and Route 17A
(Main Street)**

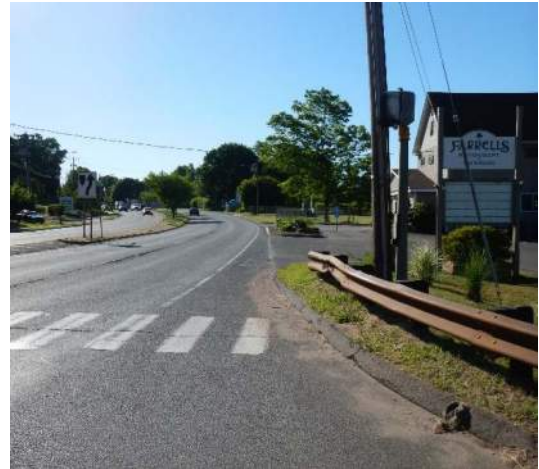
- Similarly, crosswalks and pedestrian signals exist on the east leg of the intersection of Route 66 at Airline Avenue with pedestrian crossing provided via an exclusive pedestrian phasing. ADA compliant sidewalk ramps are not provided at this intersection.

Non-compliant ADA pedestrian accommodations at the intersection of Route 66 and Airline Avenue

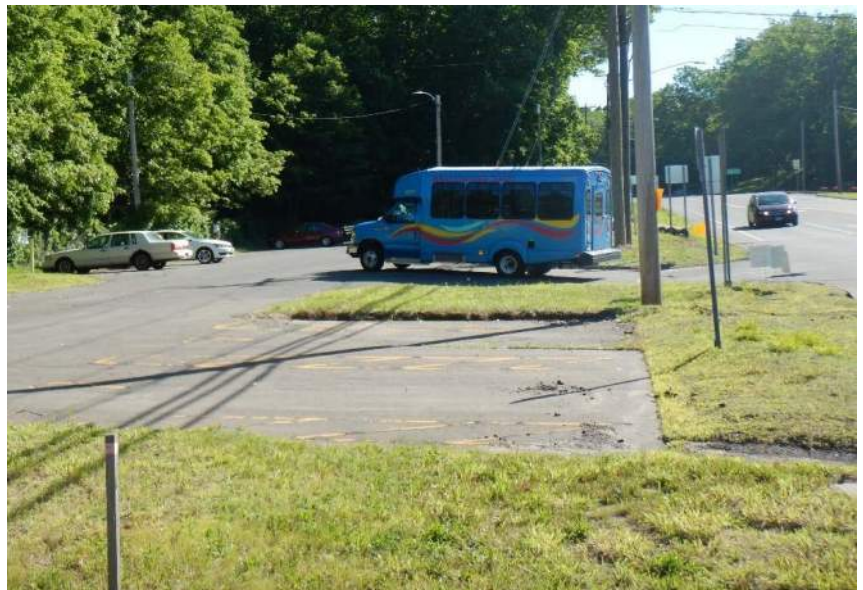
A Park and Ride lot with 27 parking spaces is provided at the intersection of Route 66 and Route 16 in East Hampton. The Park and Ride commuter lot helps to facilitate ridesharing to reduce transportation costs, roadway congestion, and air pollution. A field visit of the area indicates that the existing park and ride lot is very lightly utilized.

Park & Ride Lot at Route 66 and Route 16 (Middletown Avenue) in East Hampton

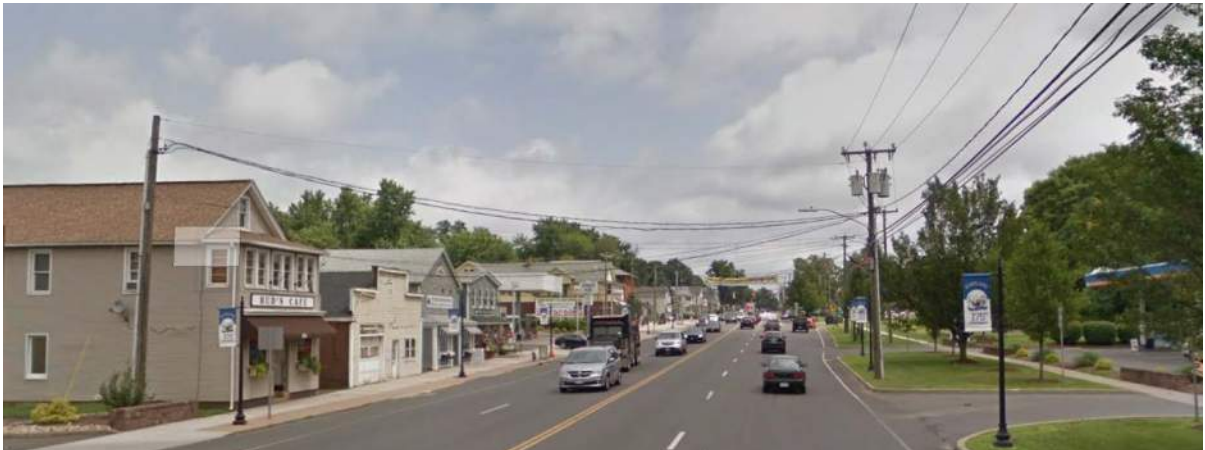
- A number of properties have multiple full-access driveways, which result in potential conflicts on the roadway.
- Some driveways are located within 25 feet of a major intersection, making the driveway access challenging and a safety concern.
- A number of driveways are closely spaced at adjacent properties, which generates confusion for travelers unfamiliar to the area as well as for drivers accessing and egressing from closely spaced driveways.
- Many driveways are poorly delineated and the pavement is in poor condition or non-existent.

Route 66 in Portland looking north near the Gulf Gas Station

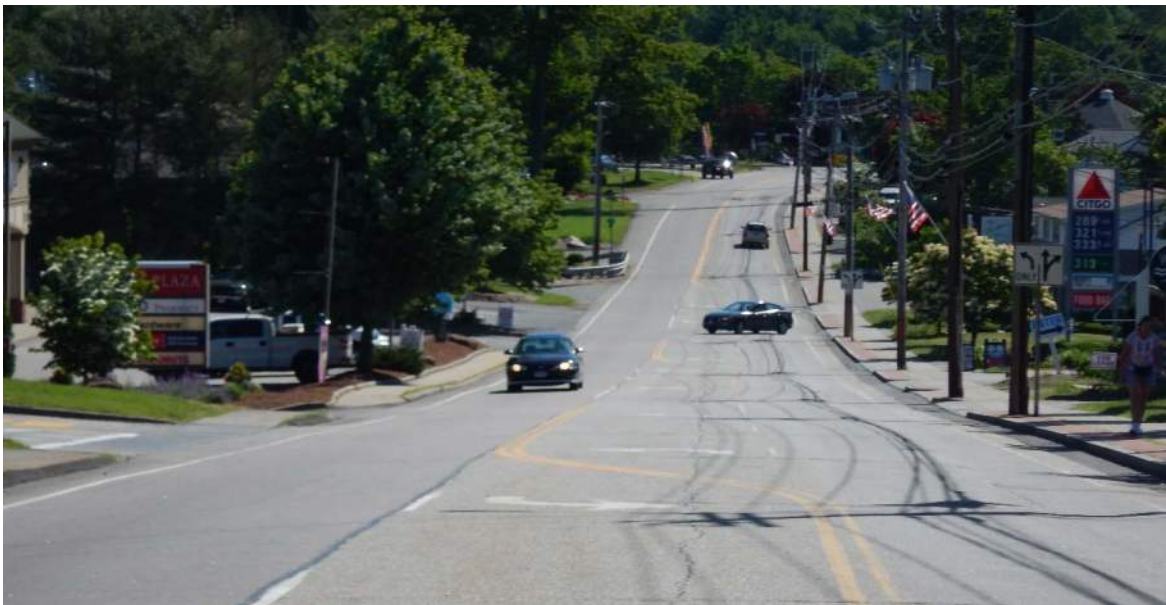
- Some poor pavement conditions along the roadway gutter in front of some driveways results in slower entering/existing turning movements which can decrease safety along this segment given all the turning movements that take place.

Route 66 in East Hampton looking East near the East Hampton Town Hall

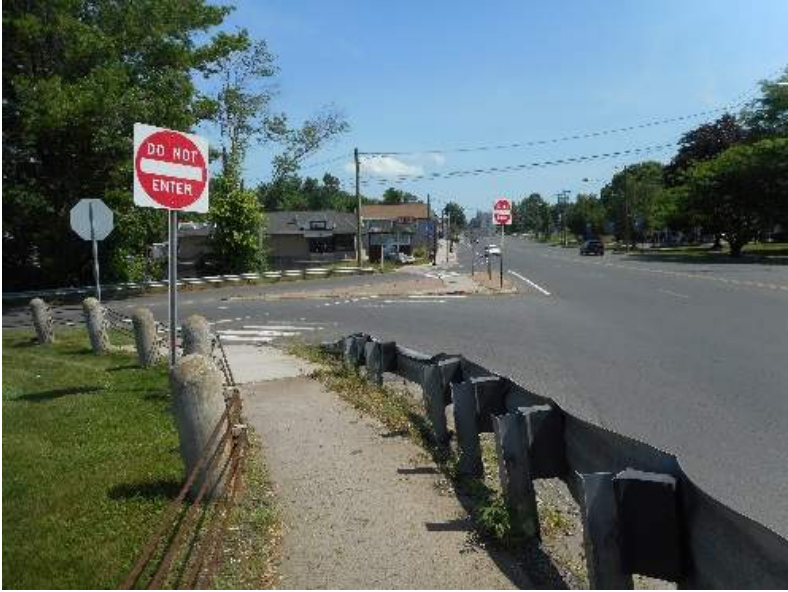
<p>Photo 1</p>

<p>Arrigoni Bridge Gateway Area: Poor sight lines, expansive pavement, lacks human scale</p>	<p>Looking North along Main Street</p>

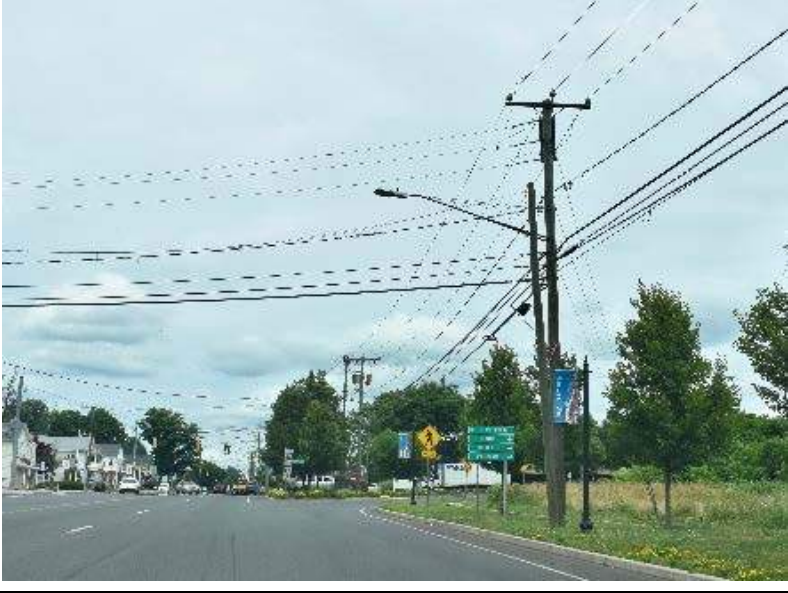
<p>Photo 2</p>

<p>Wide roadway & overhead utilities dominate streetscape</p>	<p>Looking North along Main Street</p>

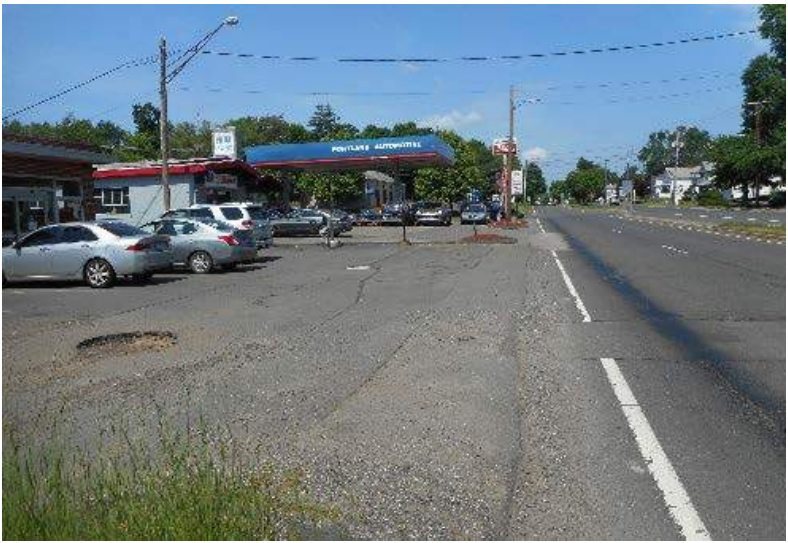
<p>Photo 7</p> <p>Excessive wide curb cuts; lack of pedestrian amenities</p>

<p>Looking West along Route 66 near Pickering Street</p>
-----------------------------------------------------------------------------------------	---------------------------------------------------------------------------------------------------------------------------------------------

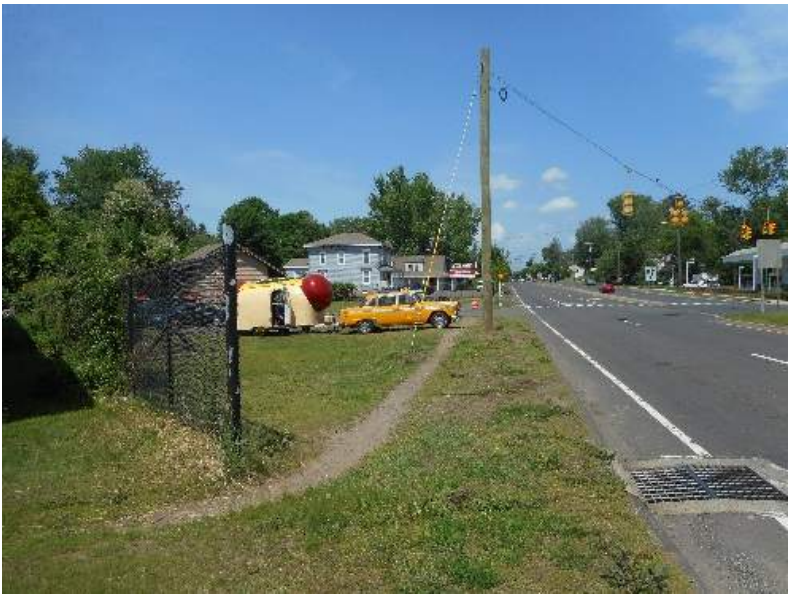
<p>Photo 9</p> <p>No sidewalk along south side; narrow shoulder limits bicycle access</p>

<p>Looking West on Route 66 at Airline Avenue</p>
--------------------------------------------------------------------------------------------------	--------------------------------------------------------------------------------------------------------------------------------------

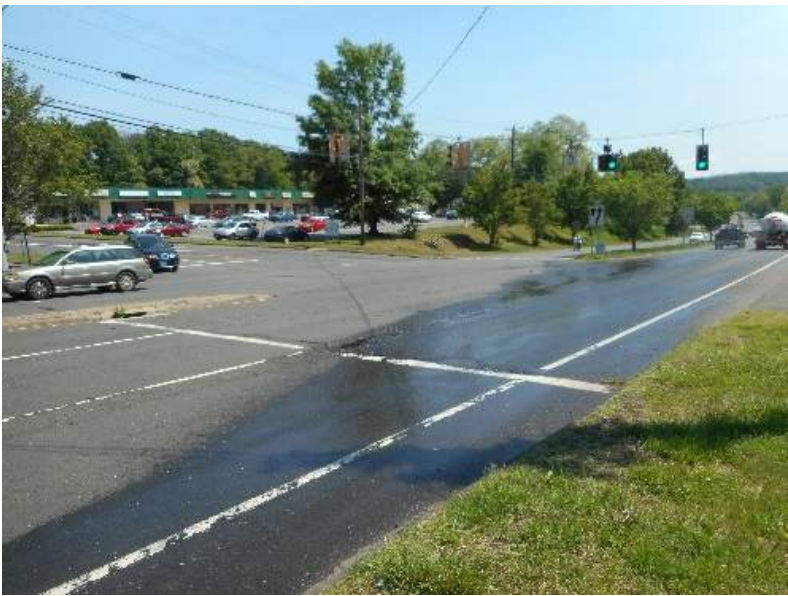
<p>Photo 10</p> <p>Signaled intersection lacks pedestrian crossing & bus provisions</p>

<p>Looking East on Route 66 at the Portland Shopping Center</p>
----------------------------------------------------------------------------------------------------	------------------------------------------------------------------------------------------------------------------------------------------------------

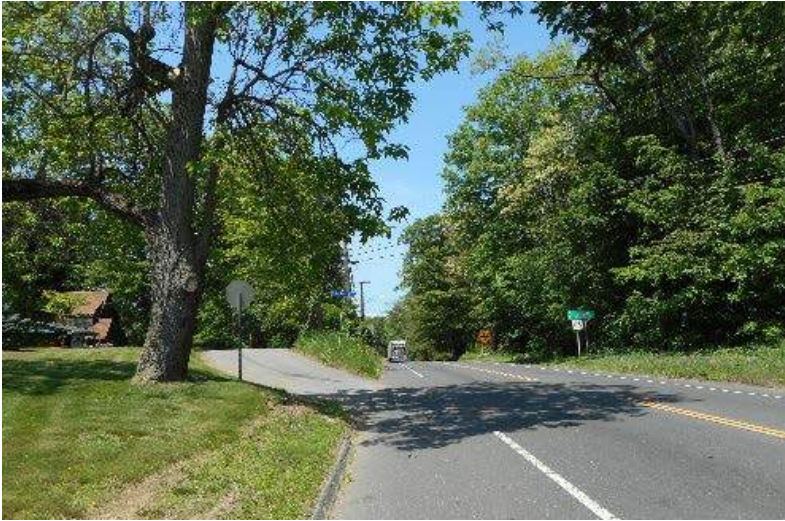
<p>Photo 1</p>

<p>One of many skewed intersecting roads with difficult sight lines</p>	
<p>Looking West along Route 66 near Middle Haddam Road</p>

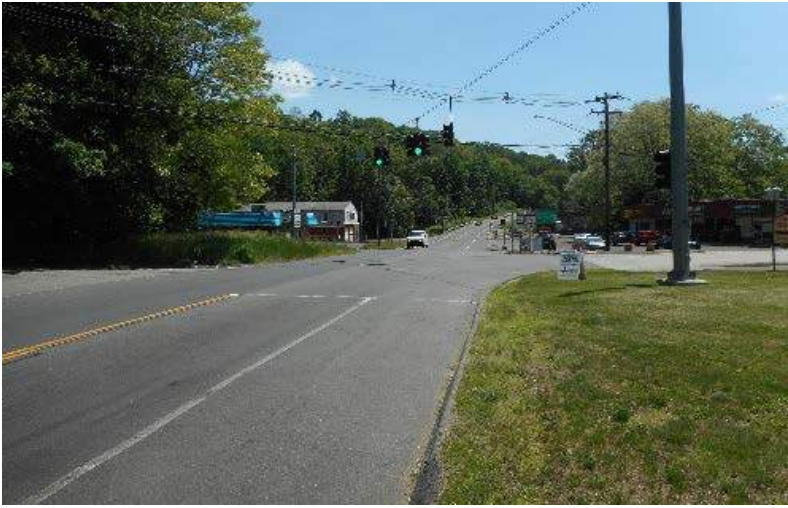
<p>Photo 2</p>

<p>Vehicle / pavement dominated gateway</p>	<p>Looking East along Route 66 at Middle Haddam Road</p>

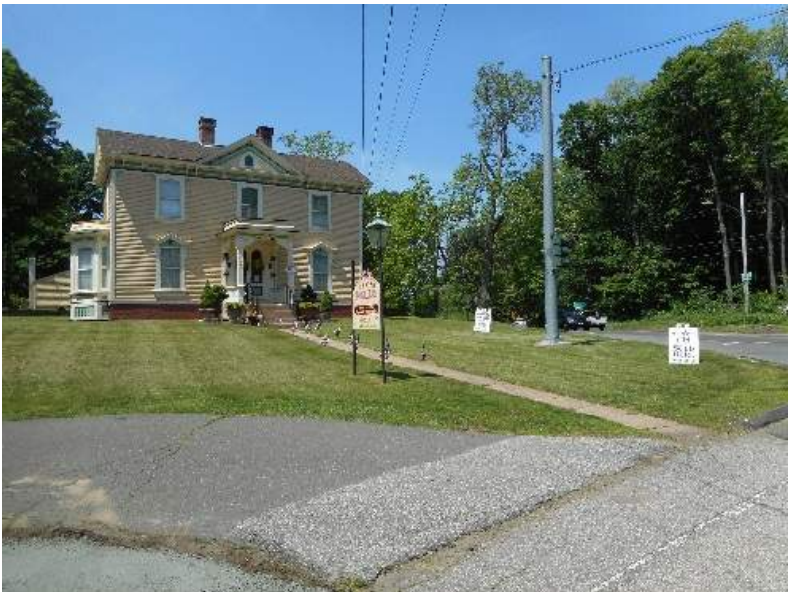
<p>Adaptive reuse of historic architecture enhances sense of place</p>	<p>Looking West from Middle Haddam Road</p>

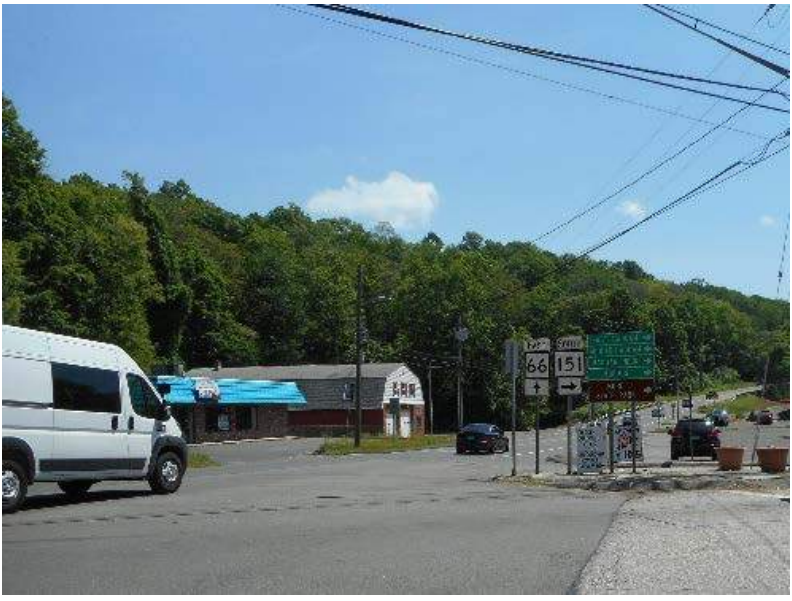
<p>Photo 4</p> <p>Intersection lacks pedestrian crosswalks & ramps; bituminous islands & excessive pavement lack visual interest</p>

<p>Looking East along Route 66 at Middle Haddam Road</p>
-----------------------------------------------------------------------------------------------------------------------------------------------------	---------------------------------------------------------------------------------------------------------------------------------------------

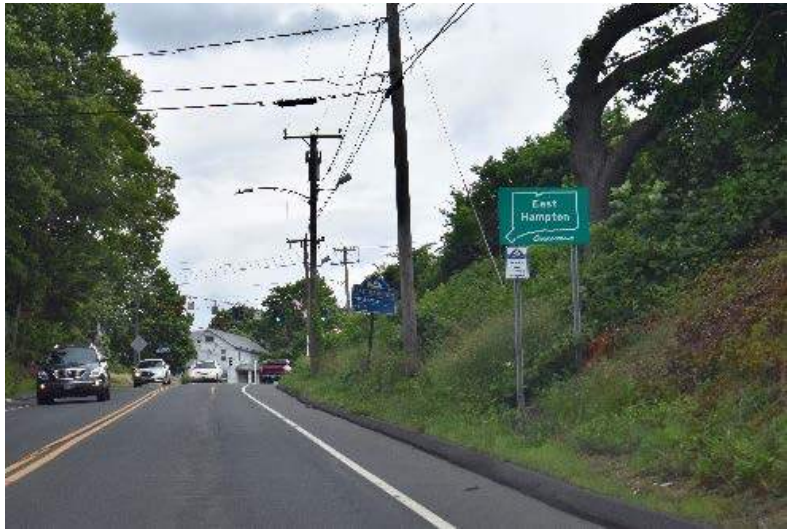
<p>Gateway signage & steep slope approaching commercial center</p>	<p>Looking East along Route 66 near Maple Street</p>

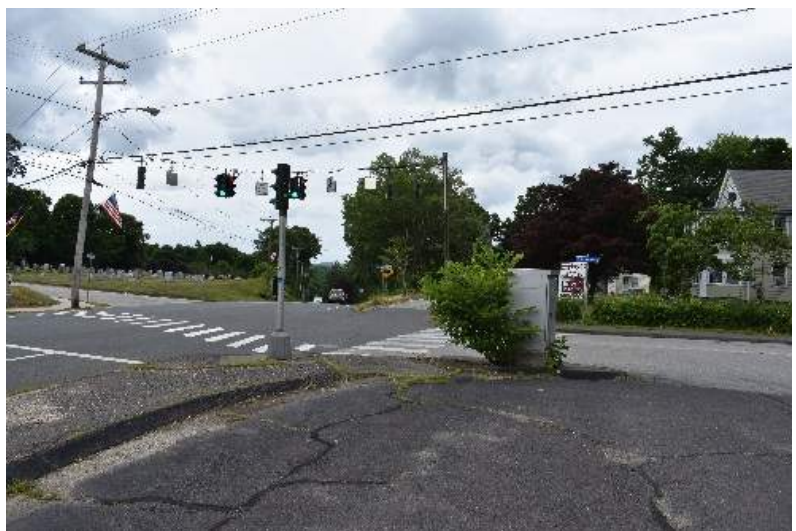
Photo 2
Signaled intersection lacks pedestrian crossing & bus provisions

Looking Southeast at Route 66 and Maple Street

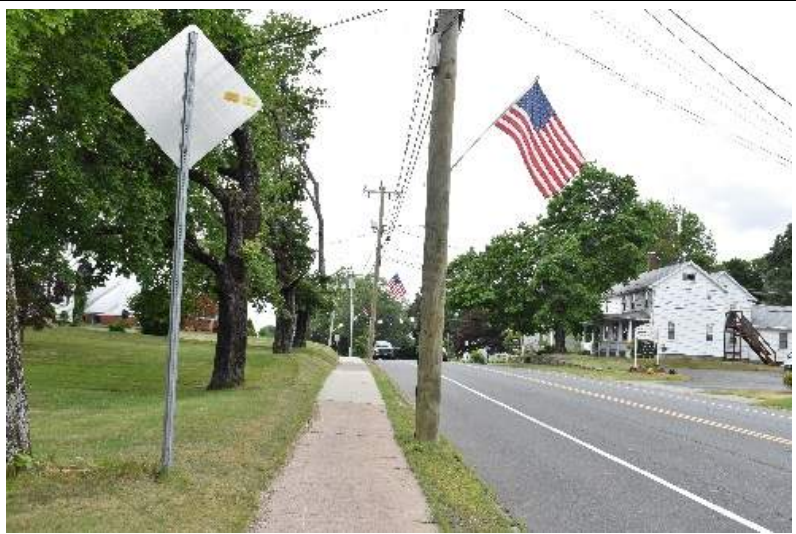
Photo 3
Overhead utilities dominate; misshapen trees. Flags on utility poles are a repetitive element throughout East Hampton.

Looking West along Route 66 near Maple Street

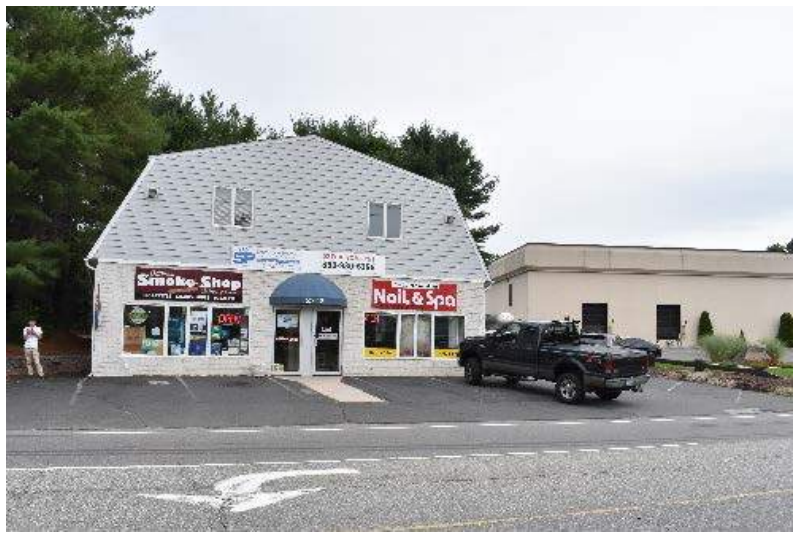
Photo 10

Front yard parking backs into the road; gap in sidewalk on north side

Looking North from Route 66 near Mallard Cove
